JULY 1967
REPORT SM-49105-F1

STRESS CORROSION CRACKING OF TITANIUM ALLOYS AT AMBIENT TEMPERATURE IN AQUEOUS SOLUTIONS

YEARLY SUMMARY REPORT
JULY 1966 THROUGH JUNE 1967
UNDER CONTRACT NAS 7-488

MISSILE & SPACE SYSTEMS DIVISION
DOUGLAS AIRCRAFT COMPANY, INC.
SANTA MONICA/CALIFORNIA

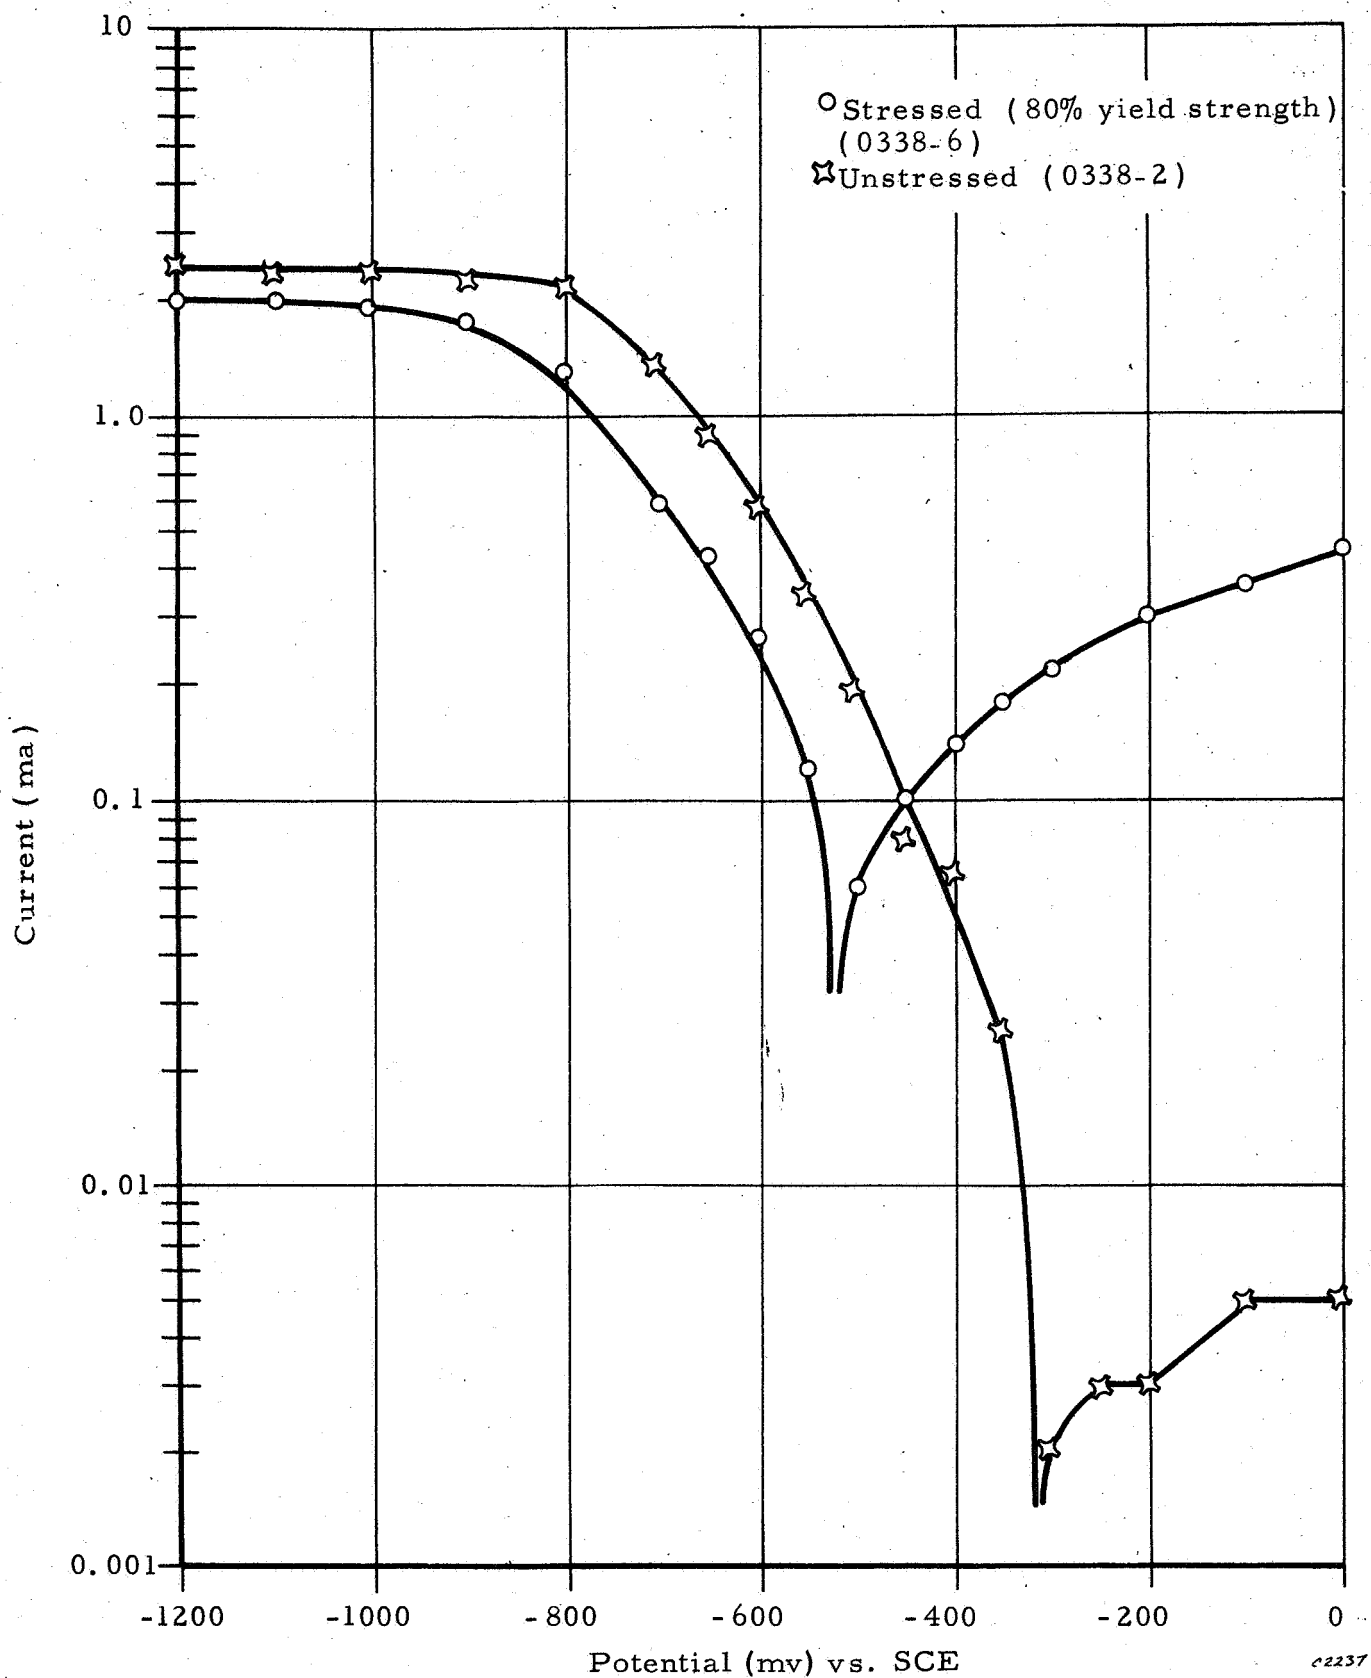
Figure 39. Effect of Stress on the Polarization Curve of Ti-6Al-4 V in 3% NaCl

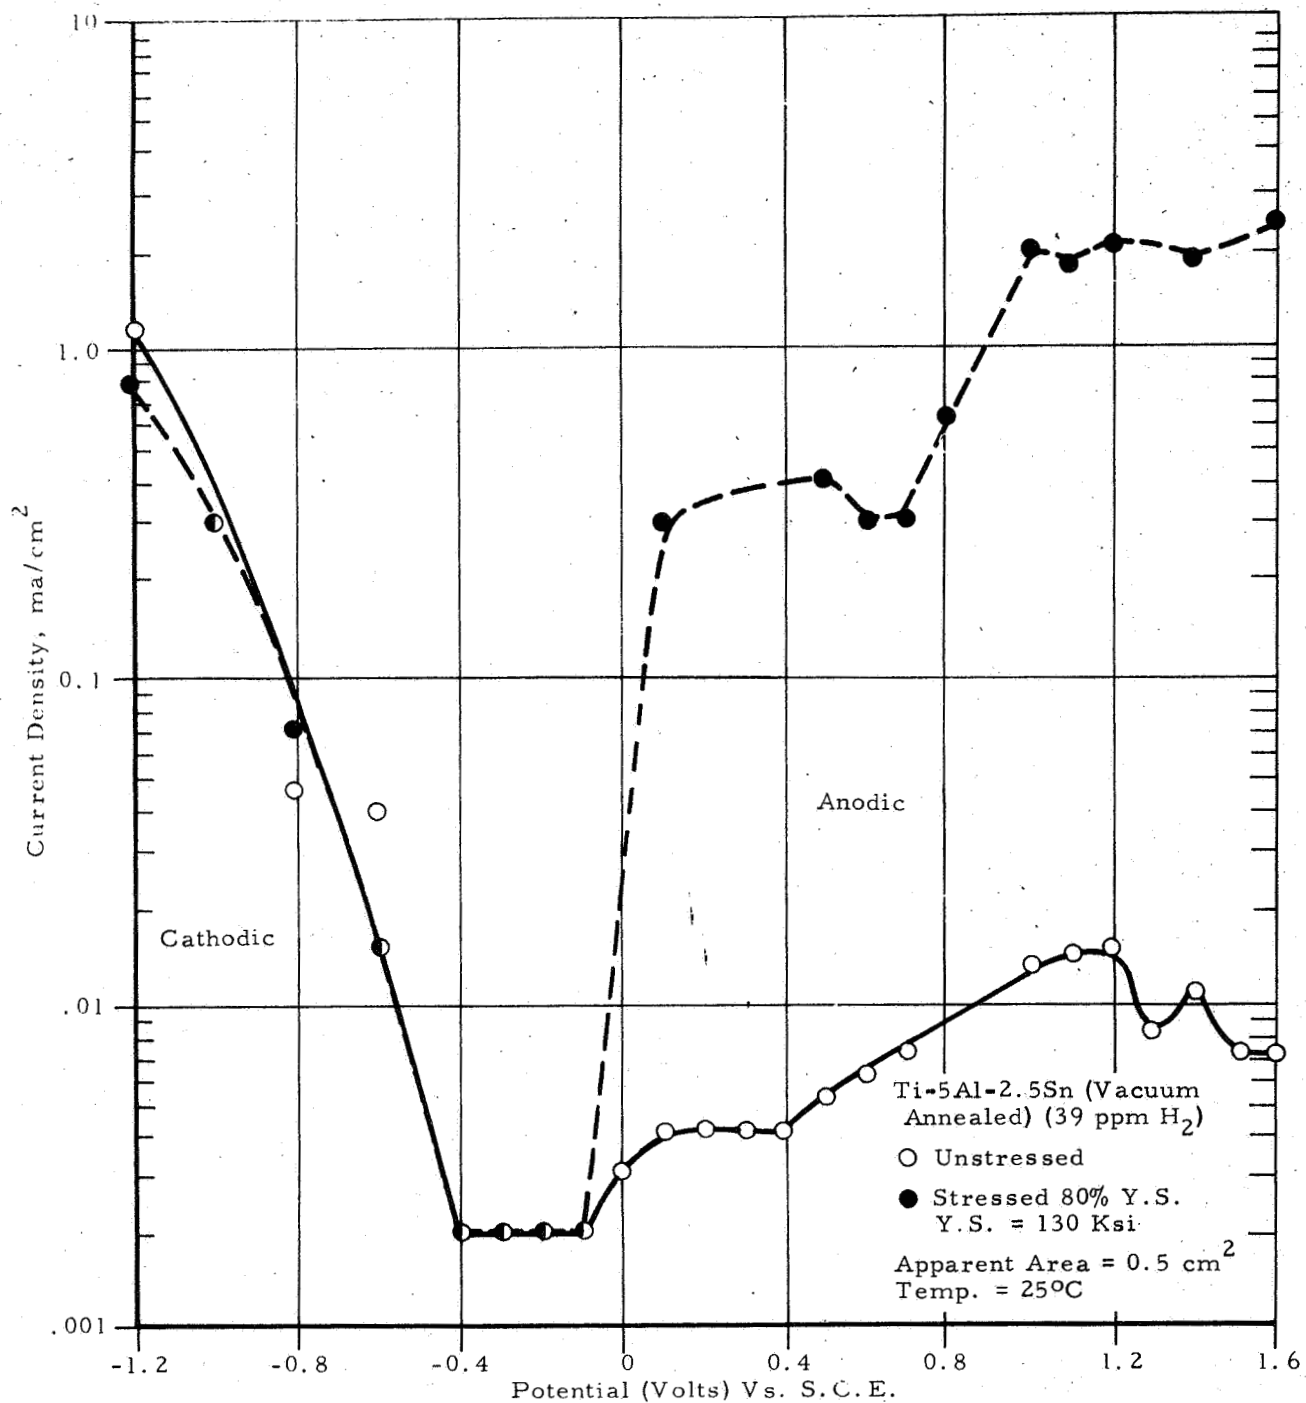
Figure 40. Polarization Curves of Vacuum Annealed Ti-5Al-2.5Sn Alloy in Oxygenated 3% NaCl, pH 6.5

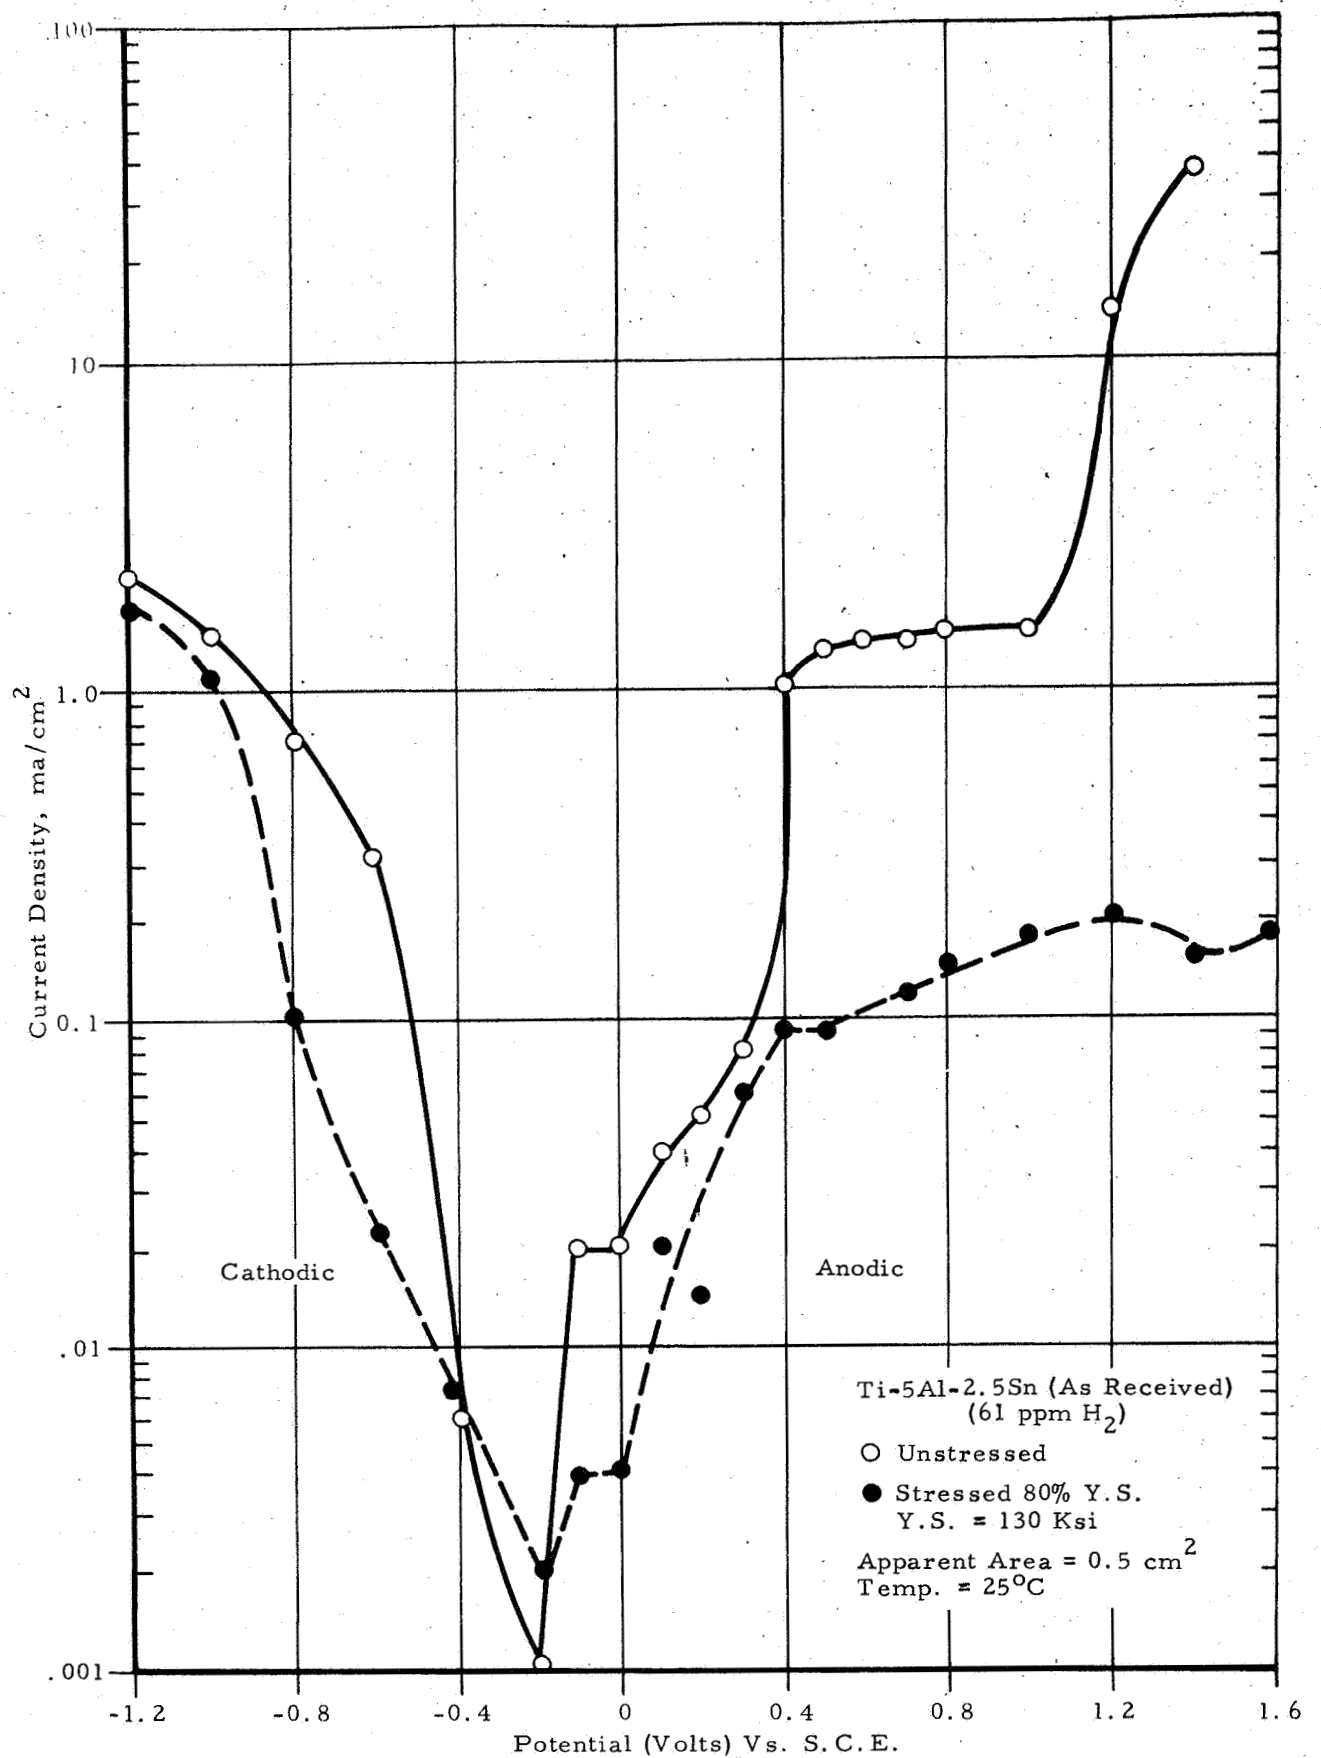
Figure 41. Polarization Curves of Ti-5Al-2.5Sn Alloy in Oxygenated 3% NaCl, pH 6.5

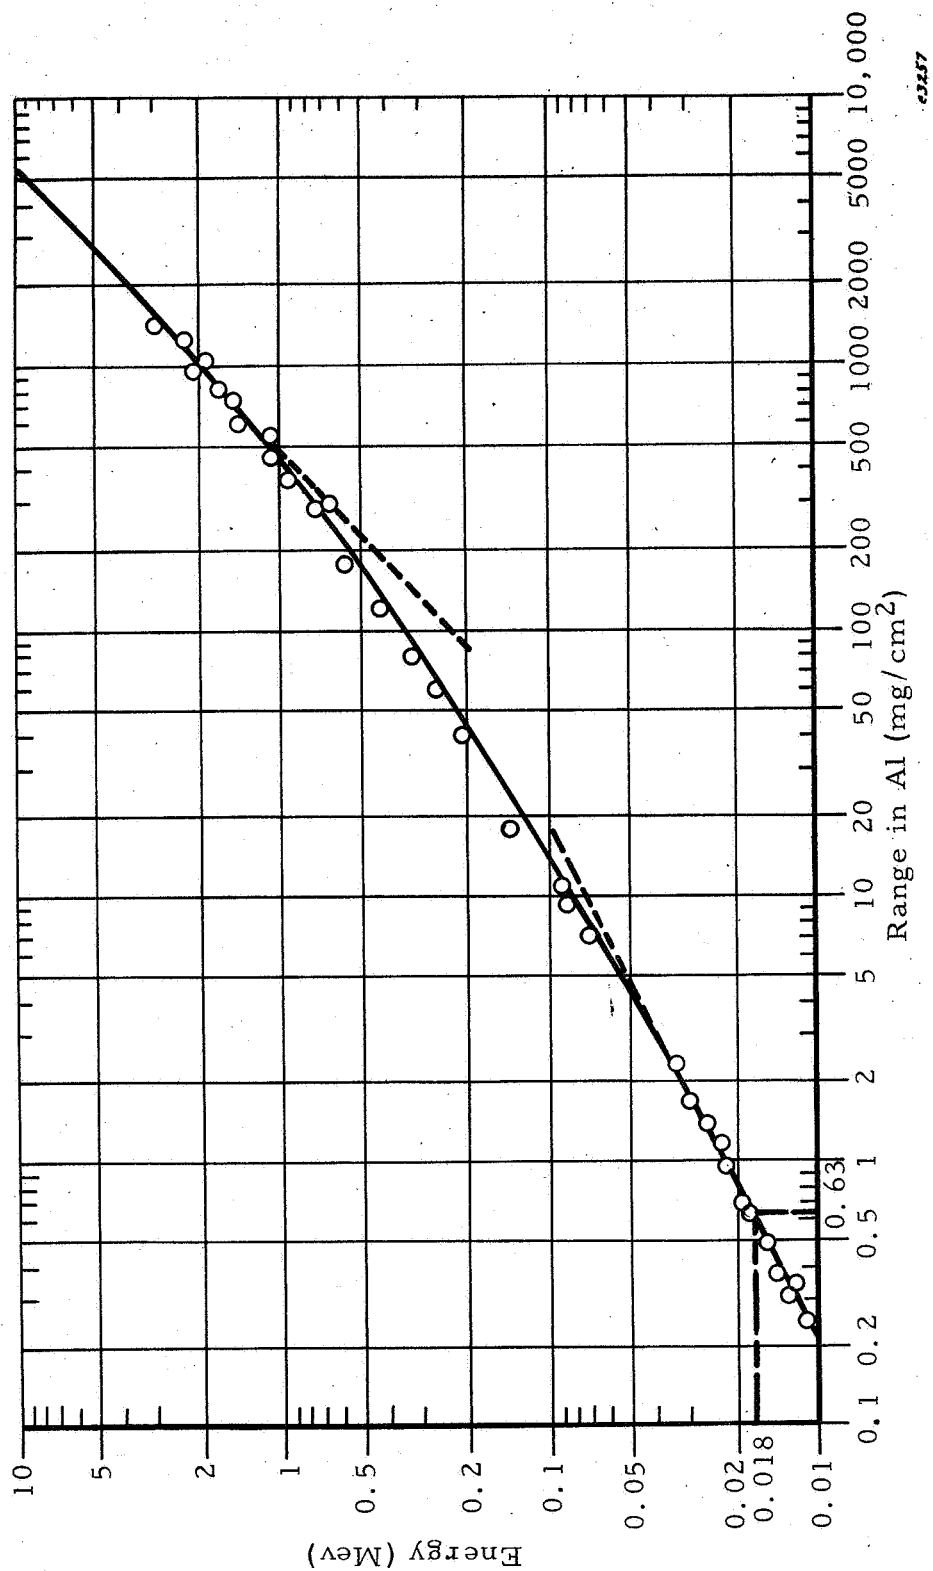
Figure A-1. Empirical Range Energy Relationship for Monoenergetic Electrons Absorbed in Aluminum According to Data From Schonland, Varder, Madgwick, Marshall and Ward, and Katz and Penfold. For nuclear electrons the range coordinate indicates the maximum range R_m . The H^3 -beta R_m in aluminum is 0.63 mg/cm² (Reference 2).

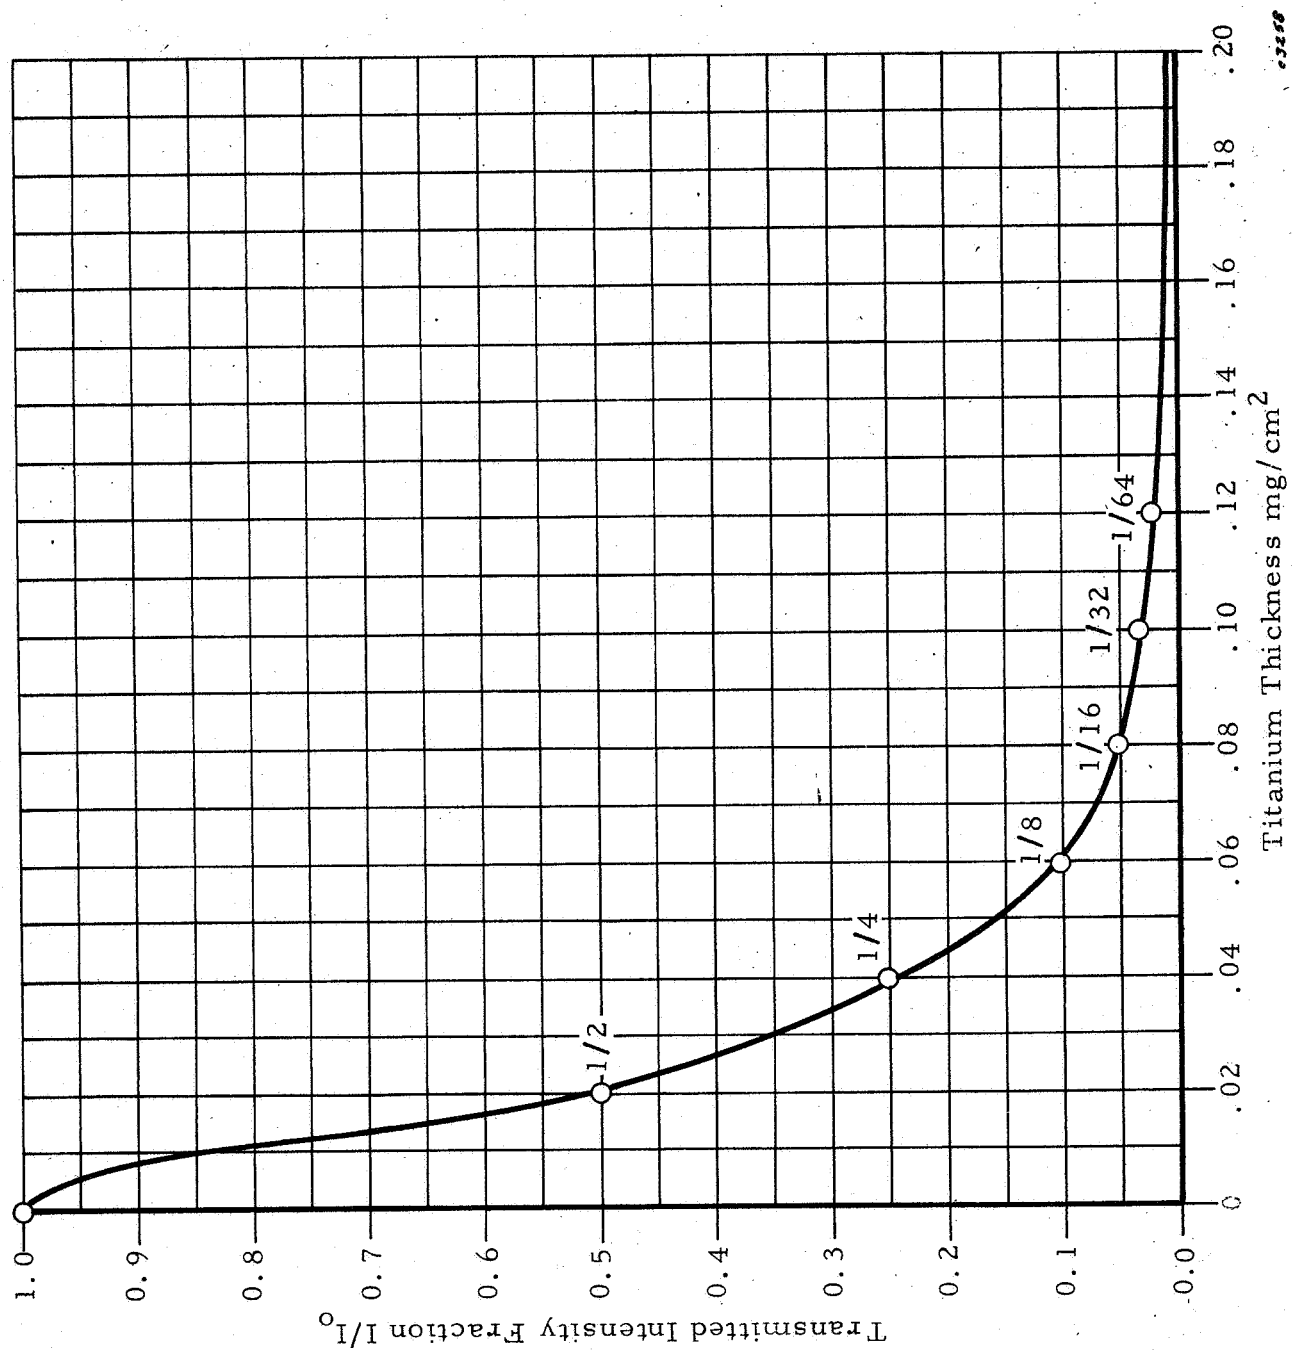
Figure A-2. Transmitted Tritium Beta (Energy Intensity Fraction Versus Titanium Mass Thickness)

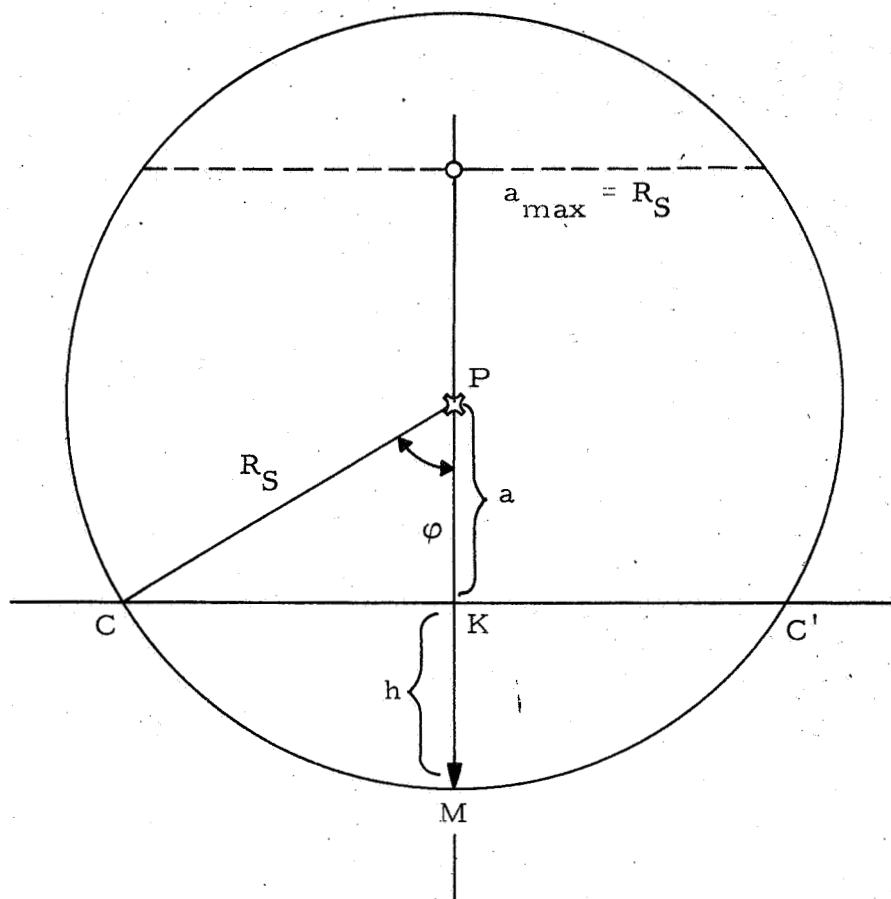
Figure A-3. Spatial Distribution of Disintegration Signals From a Point Source P at a Distance (a) From the Emulsion Surface CKC' .

$$\frac{\text{area of spherical segment}}{\text{area of sphere}} = \frac{2\pi R_S^2 (1 - \cos \varphi)}{4\pi R_S^2} = \frac{1 - \cos \varphi}{2}$$
